Manhole Inspection Summary

Manhole # S45G__035MH

Insp Date: **7/15/08 12:42 PM**

Location Address: **219 s. castle st.**

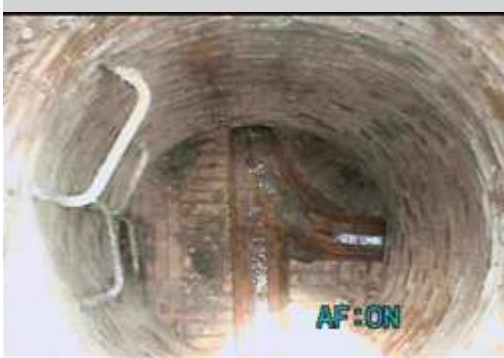
defect 2

Count: **4** Missing: **0** ☒ **Corroded**

& steps

corroded steps

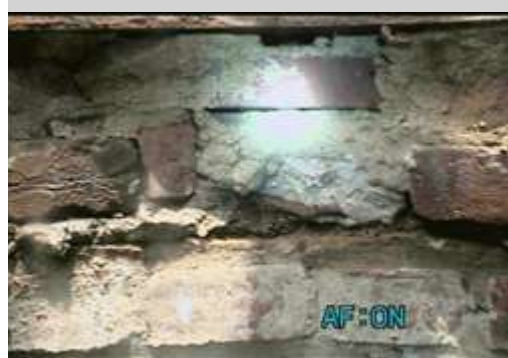
Defect 1

Condition: ☐ Sound ☐ Cracked ☐ Root Intrusion ☒ **Loose Brick** ☒ **Deteriorated**

chimney loose bricks frame adj.

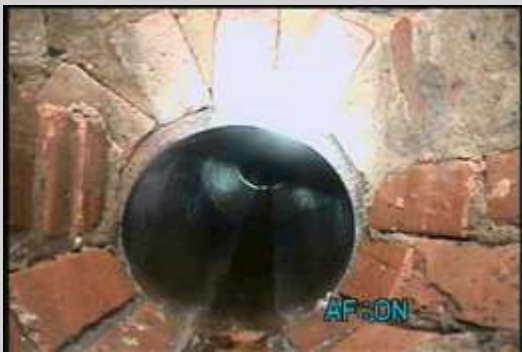
12 O'Clock Outflow

8 in. Circular Gravity Sewer
Pipe Out @ 12 O'Clock

Invert Depth: **9.45** (ft.) Flow Characteristics: **Fast**

Infiltration: **None** Pipe Seal Cond: **Unknown**

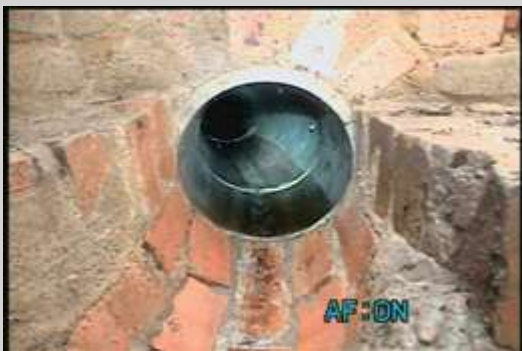
3 O'Clock Inflow

8 in. Circular Gravity Sewer
Pipe In @ 3 O'Clock

Invert Depth: **8.85** (ft.) Flow Characteristics: **Slow**

Infiltration: **None** Pipe Seal Cond: **Unknown**

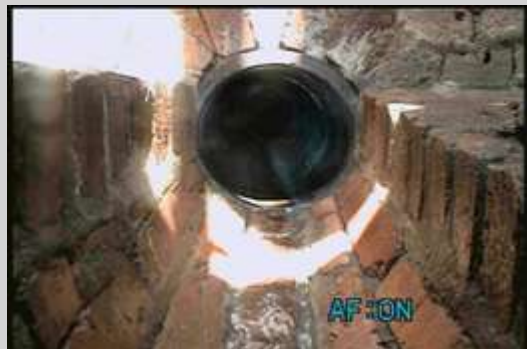
6 O'Clock Inflow

8 in. Circular Gravity Sewer
Pipe In @ 6 O'Clock

Invert Depth: **8.94** (ft.) Flow Characteristics: **Fast**

Infiltration: **None** Pipe Seal Cond: **Unknown**
